# Exploratory Crash Tests of an FRP End-Terminal: FOIL Test Numbers 96F007, 96F016, 96F024, and 96F027

PUBLICATION NO. FHWA-RD-97-070

JULY 1997

U.S. Department of Transportation  
**Federal Highway Administration**

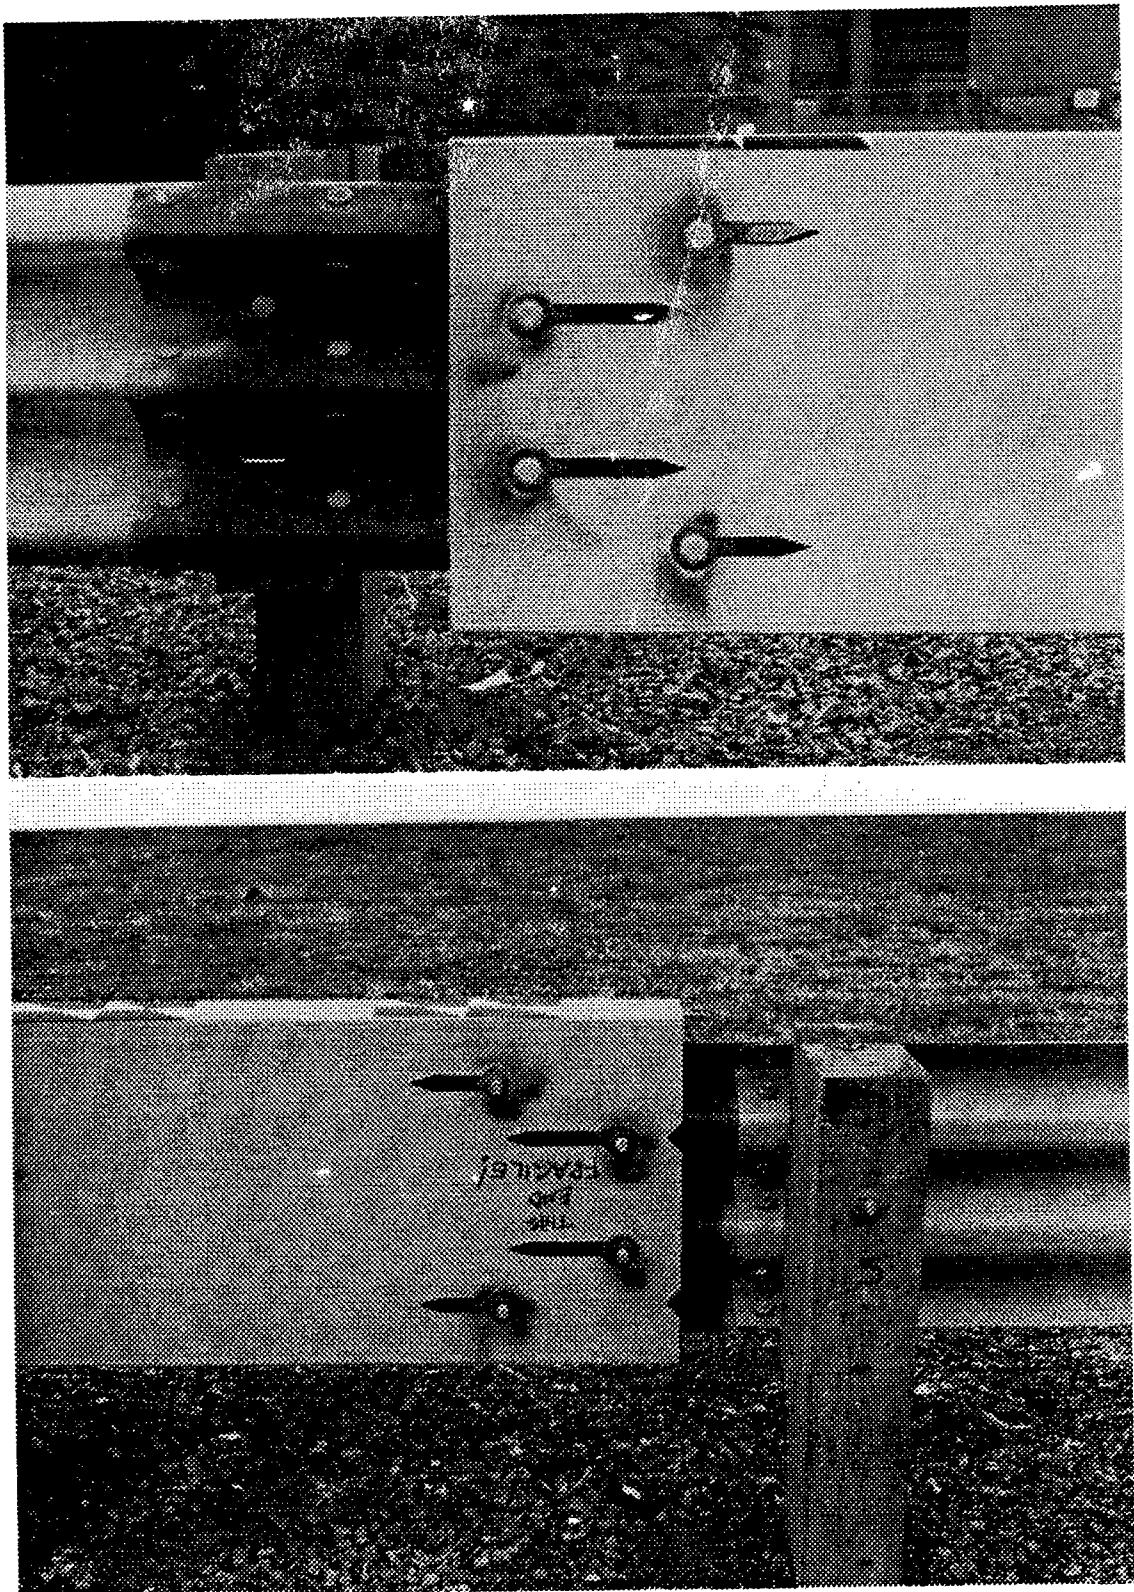
Figure 2. Photographs of the nose section and end-anchorage.

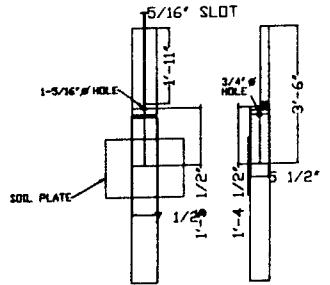
C-A-T WOOD POST (POST 1)  
FOUNDATION TUBE & SOIL PLATE  
PC# 3075B (Modified)

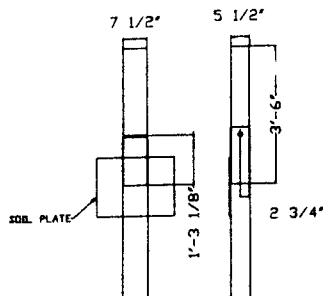
C-A-T WOOD POST (POST 2)  
FOUNDATION TUBE & SOIL PLATE  
PC# 4147B

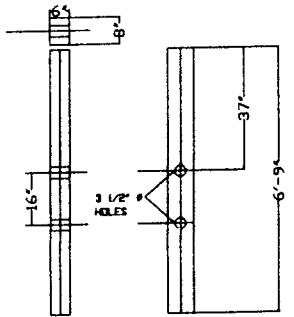
CRT WOOD POST (POSTS 3 & 4)  
PC# 5931B

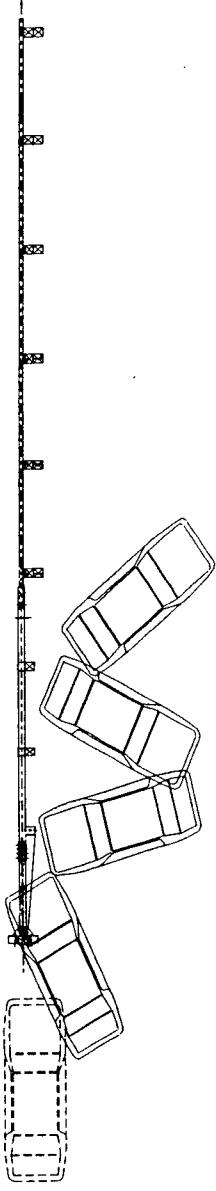
Test number.....	96F007	Vehicle analysis:	Observed	Design/Limit
Date.....	March 13, 1996		Longitudinal: Occupant Delta V at 0.6 m.....	12.8 m/s	9/12 m/s
Test vehicle.....	1988 Ford Festiva		Ridedown acceleration.....	14.9 g's	15/20 g's
Vehicle weight.....	816 kg		Lateral: Occupant Delta V at 0.3 m.....	2.2 m/s	9/12 m/s
Test article.....	FRP composite		Ridedown acceleration.....	2.5 g's	15/20 g's
Total length.....	4.5 m		Peak 50 ms acceleration:		
Terminal.....	6.5 m		Longitudinal.....	18.2 g's	
FRP box-section length.....	4.3 m		Lateral.....	NA	
Guardrail type.....	12 gauge w-beam		Vehicle Damage:		
Rail height.....	685 mm		Traffic Accident Data (TAD) .....	..12-FL-5	
Foundation.....	FOIL clay		Vehicle Damage Index (VDI) .....	..12FYEW5	
Impact speed.....	100.7 km/h		Vehicle crush.....	.....502 mm	
Impact angle.....	.....0°		FRP crush stroke.....	.....1257 mm	
Impact location.....	Driver 1/4-point

Figure 11. Summary of test 96F007.

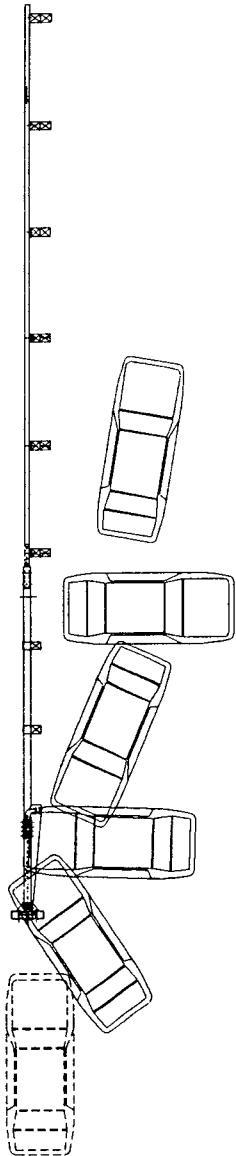
<u>Test number.....</u>	<u>Vehicle analysis:</u>	<u>Observed</u>	<u>Design/Limit</u>
Date.....	August 15, 1996	Longitudinal: Occupant Delta V at 0.6 m.....	12.3 m/s	9/12 m/s
Test vehicle.....	1988 Ford Festiva	Ridedown acceleration.....	5.5 g's	15/20 g's
Vehicle weight.....	835 kg	Lateral: Occupant Delta V at 0.3 m.....	4.3 m/s	9/12 m/s
	No dummy	Ridedown acceleration.....	8.0 g's	15/20 g's
Test article.....	FRP composite	Peak 50 ms acceleration:	.....	17.7 g's
Total length.....	4.5 m	Longitudinal.....	.....	NA
Terminal.....	8.3 m	Lateral.....	.....	.....
FRP box-section length.....	6.1 m	Vehicle Damage:	.....	.....
Guardrail type.....	12 gauge w-beam	Traffic Accident Data (TAD).....	.....	12-FL-5
Rail height.....	685 mm	Vehicle Damage Index (VDI).....	.....	12FYEW5
Foundation.....	FOIL clay	Vehicle crush.....	.....	514 mm
Impact speed.....	95 km/h	FRP crush stroke.....	.....	318 mm
Impact angle.....	.....0°	.....	.....	.....

Impact location.....	Driver 1/4-point	.....	.....	.....

Figure 12. Summary of test 96F016.

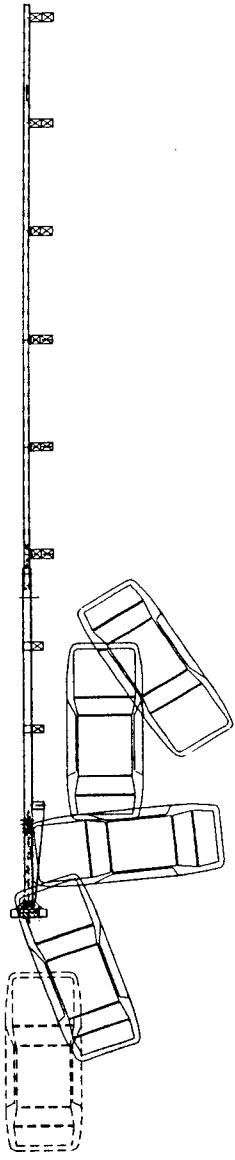
<u>Test number</u>	<u>Vehicle analysis:</u>	<u>Observed</u>	<u>Design/Limit</u>
Date.....	October 22, 1996	Longitudinal: Occupant Delta V at 0.6 m.....	13.6 m/s	9/12 m/s
Test vehicle.....	1990 Ford Festiva	Ridedown acceleration.....	11.7 g's	15/20 g's
Vehicle weight.....	816 kg No dummy	Lateral: Occupant Delta V at 0.3 m.....	2.4 m/s	9/12 m/s
Test article.....	FRP composite	Ridedown acceleration.....	1.5 g's	15/20 g's
Total length.....	4.5 m	Peak 50 ms acceleration:		NA
Terminal.....	12.2 m	Longitudinal.....		19.1 g's
FRP box-section length.....	6.1 m	Lateral.....		NA
Guardrail type.....	12 gauge w-beam	Vehicle Damage Index (VDI)		12-FI-5
Rail height.....	685 mm	Vehicle crush.....		12FYEW5
Foundation.....	FOIL clay	FRP crush stroke.....		400 mm
Impact speed.....	97.2 km/h			1130 mm
Impact angle.....	0°			
Impact location.....	Driver 1/4-point

Figure 13. Summary of test 96F024.

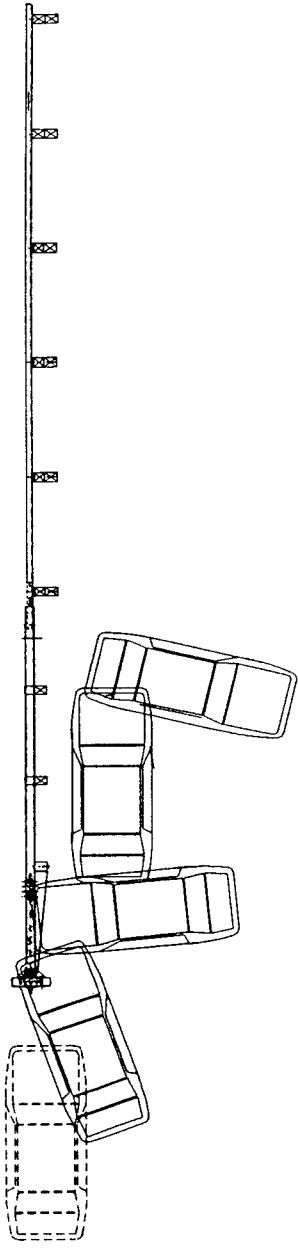
<u>Test number.....</u> .....96F027	<u>Vehicle analysis:</u>	<u>Observed</u>	<u>Design/Limit</u>
Date.....	December 20, 1996	Longitudinal: Occupant Delta V at 0.6 m.....	12.6 m/s	9/12 m/s
Test vehicle.....	1993 Ford Festiva	Ridedown acceleration.....	9.1 g/s	15/20 g/s
Vehicle weight.....	820 kg	Lateral: Occupant Delta V at 0.3 m.....	3.8 m/s	9/12 m/s
No dummy		Ridedown acceleration.....	2.6 g/s	15/20 g/s
Test article.....	FRP composite	Peak 50 ms acceleration:		
Total length.....	4.5 m	Longitudinal.....	.....17.8 g/s	
Terminal.....	12.2 m	Lateral.....	.....NA	
FRP box-section length.....	6.1 m			
Guardrail type.....	12 gauge w-beam	Vehicle Damage:		
Rail height.....	685 mm	Traffic Accident Data (TAD).....	.....12-FD-6	.....12FDW6
Foundation.....	FOIL clay	Vehicle crush.....	.....355 mm	
Impact speed.....	97.8 km/h	FRP crush stroke.....	.....533 mm	
Impact angle.....	0°			
Impact location.....	Driver 1/4-point

Figure 14. Summary of test 96F027.

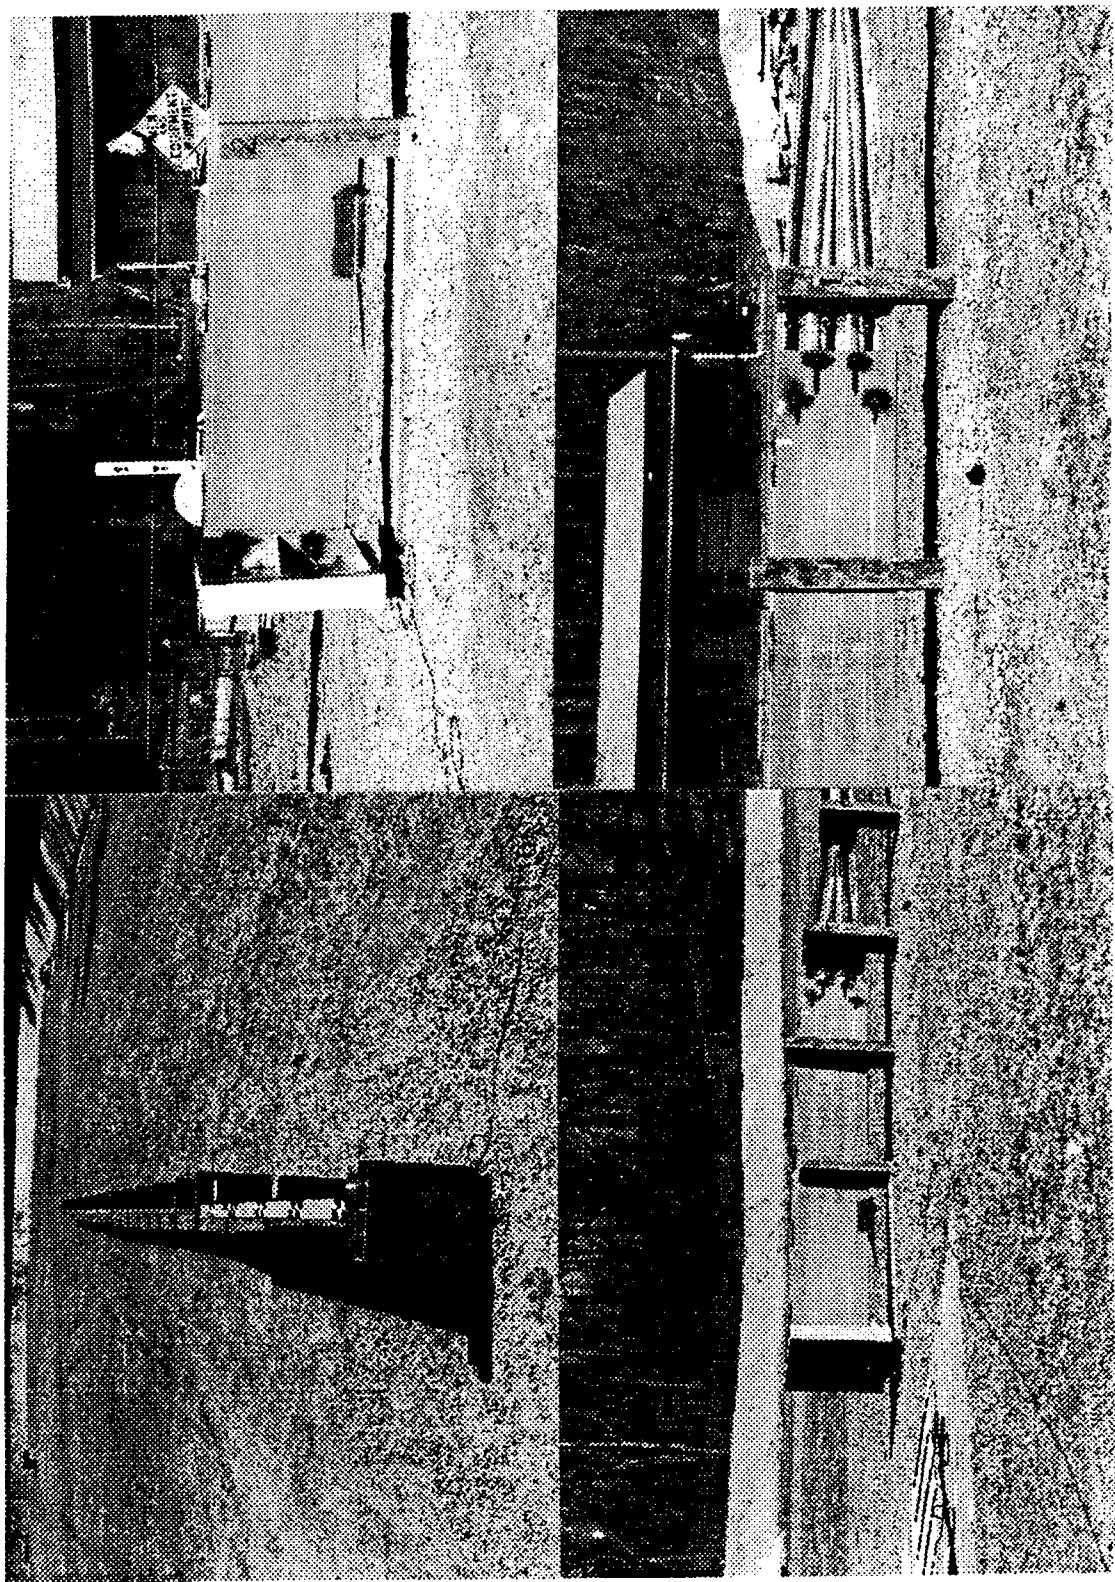
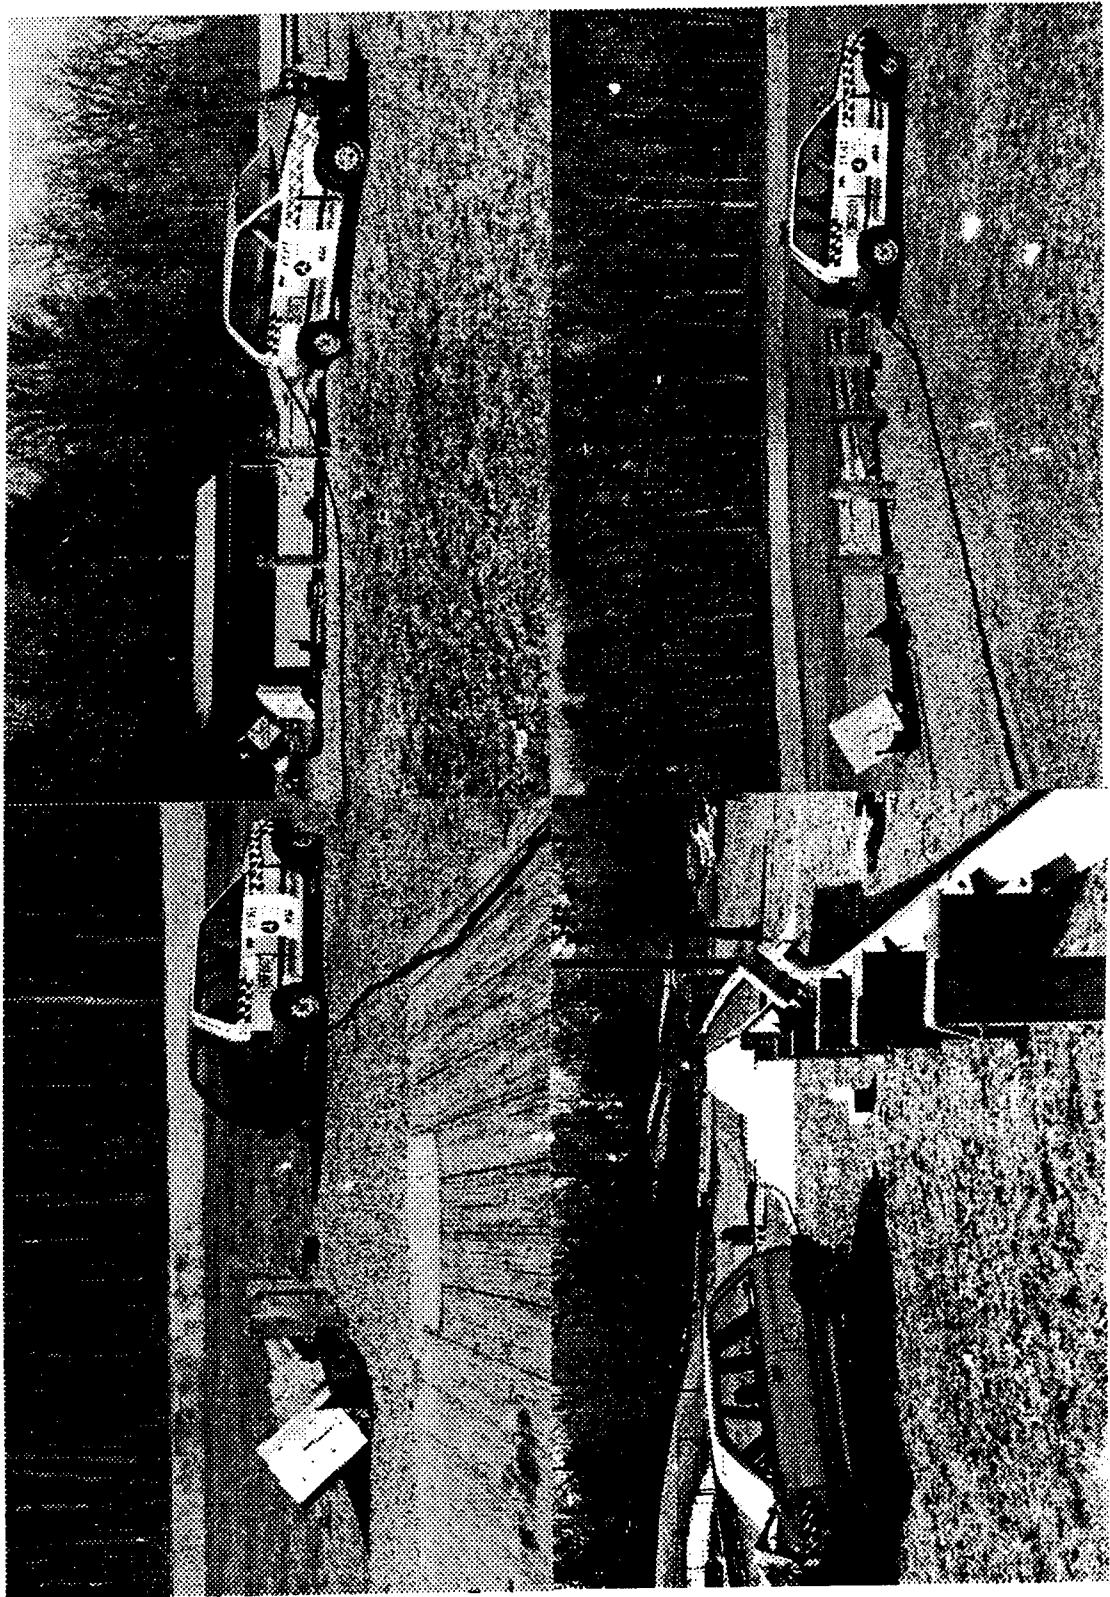
Figure 16. Post-test photographs, test 96F007.

Figure 16. Post-test photographs, test 96F007 (continued).

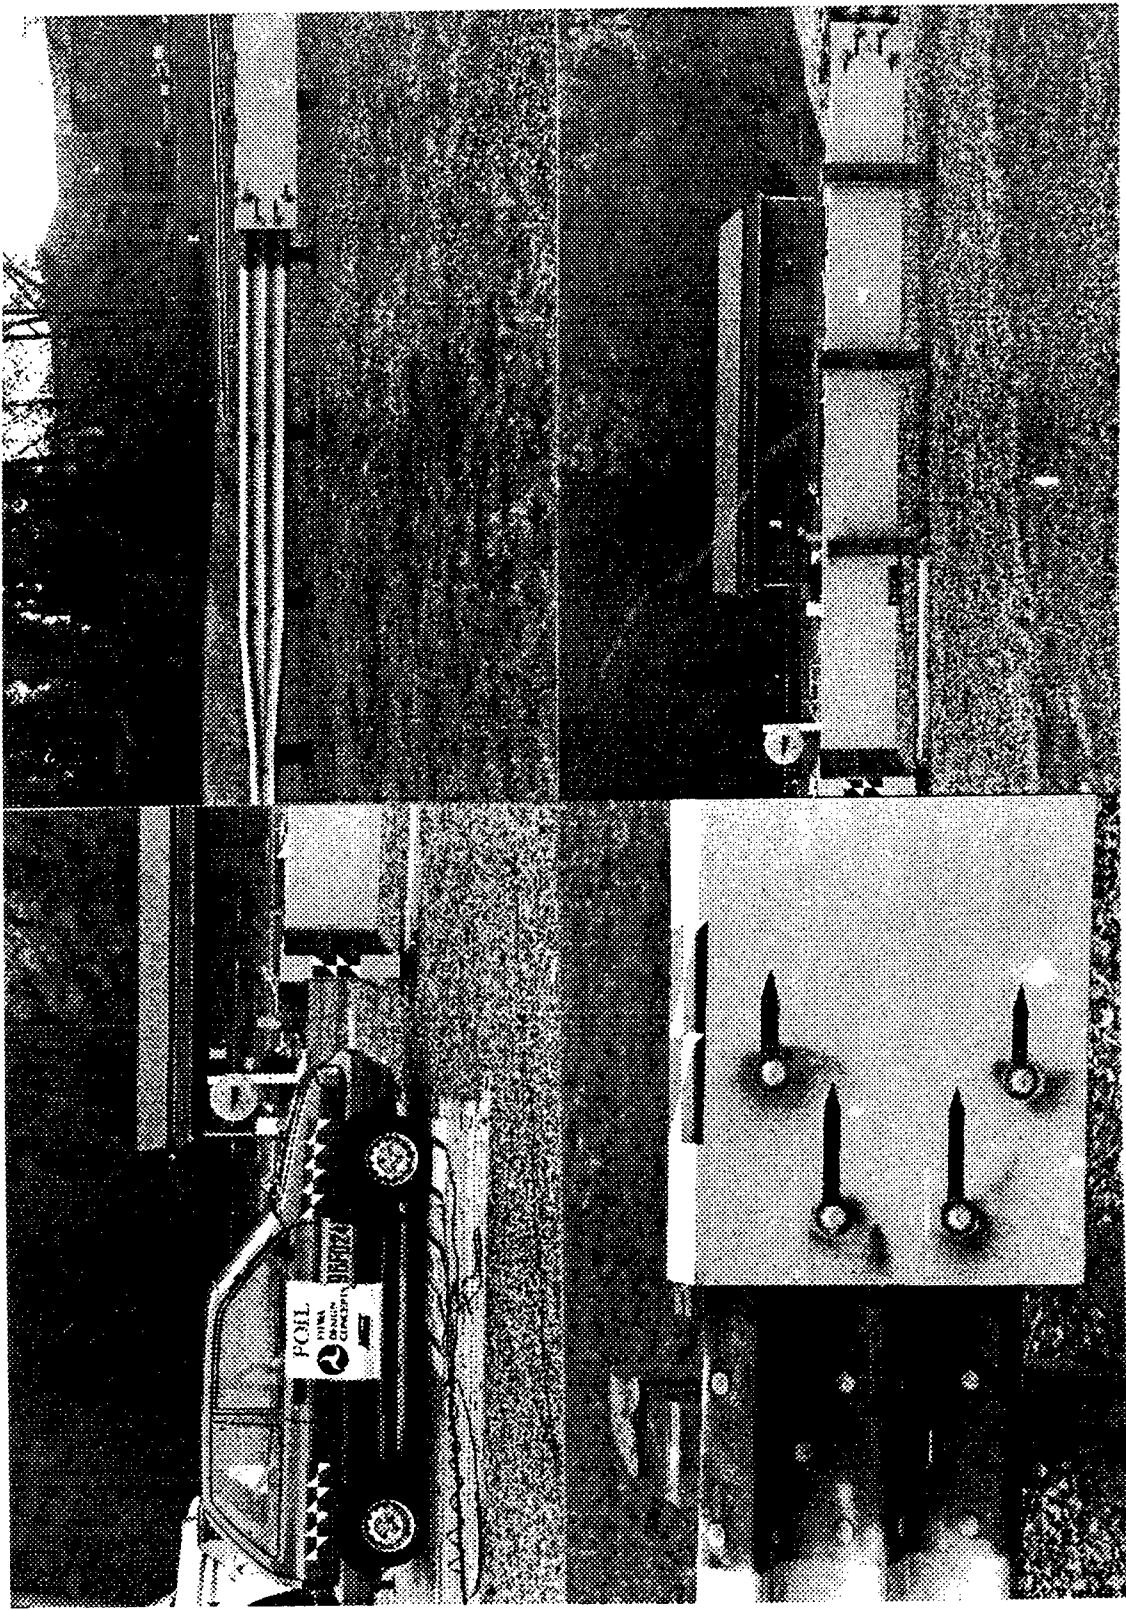
Figure 20. Post-test photographs, test 96F024.

Figure 20. Post-test photographs, test 96F024 (continued).

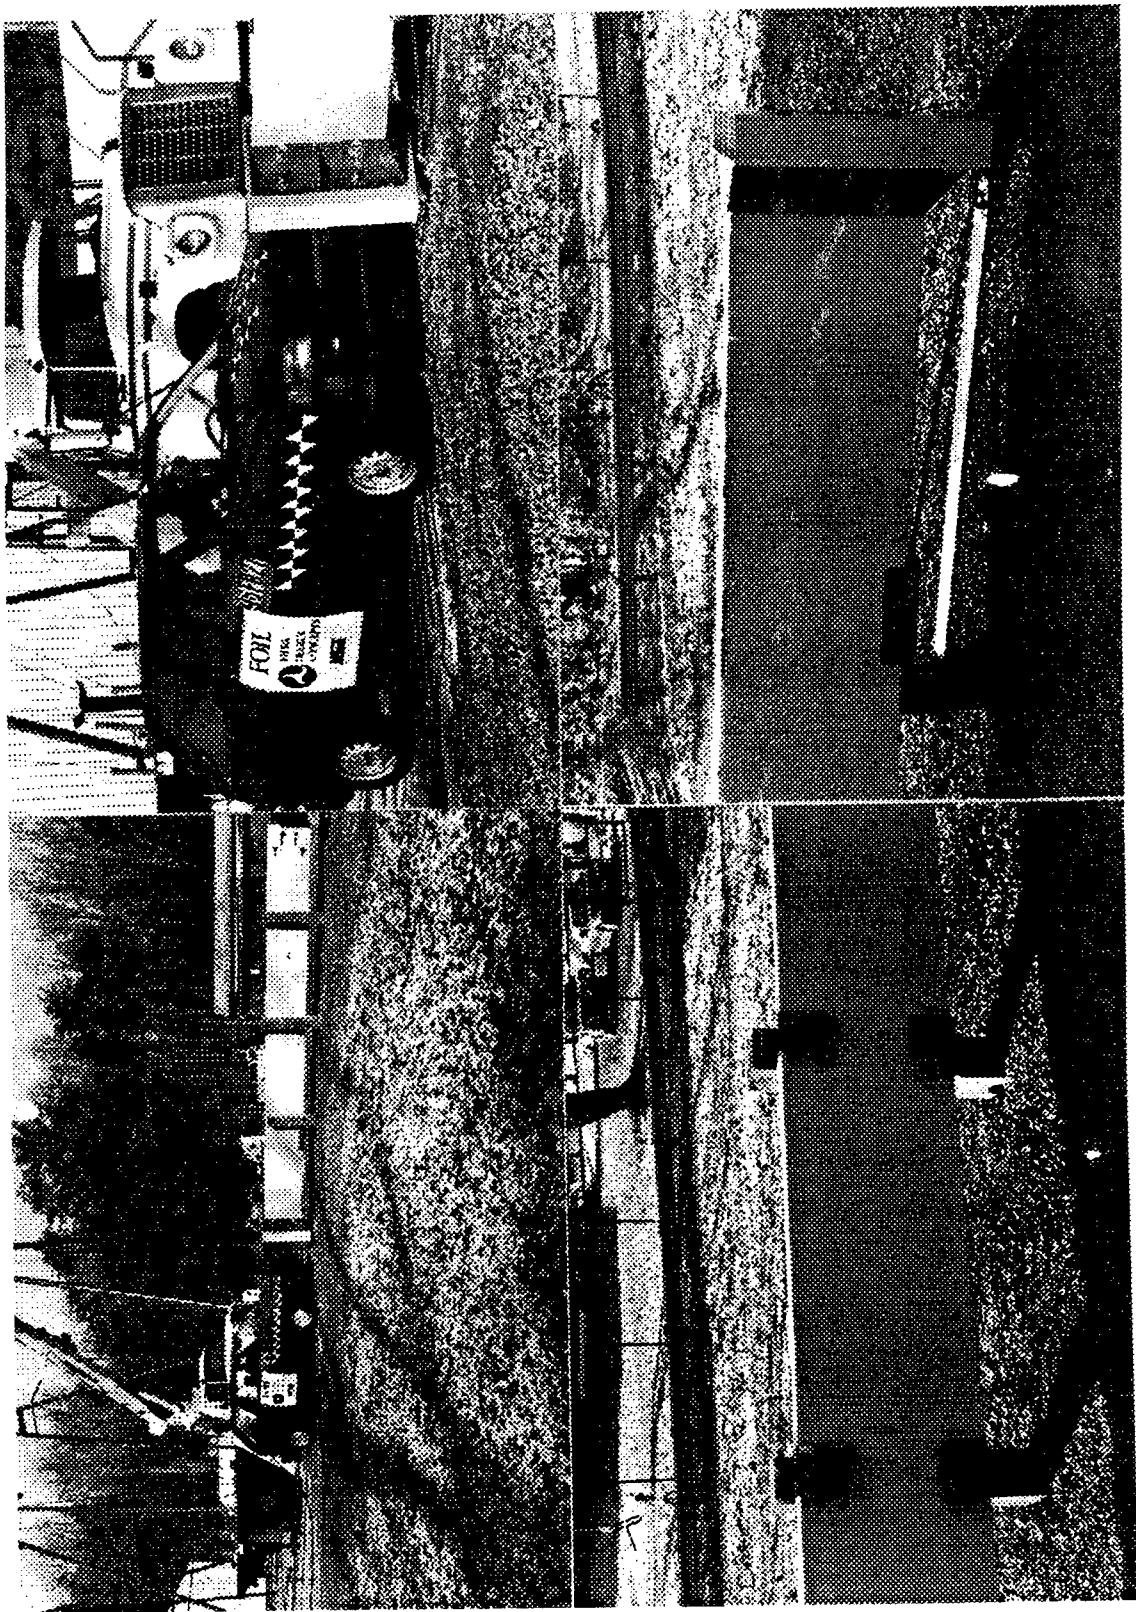
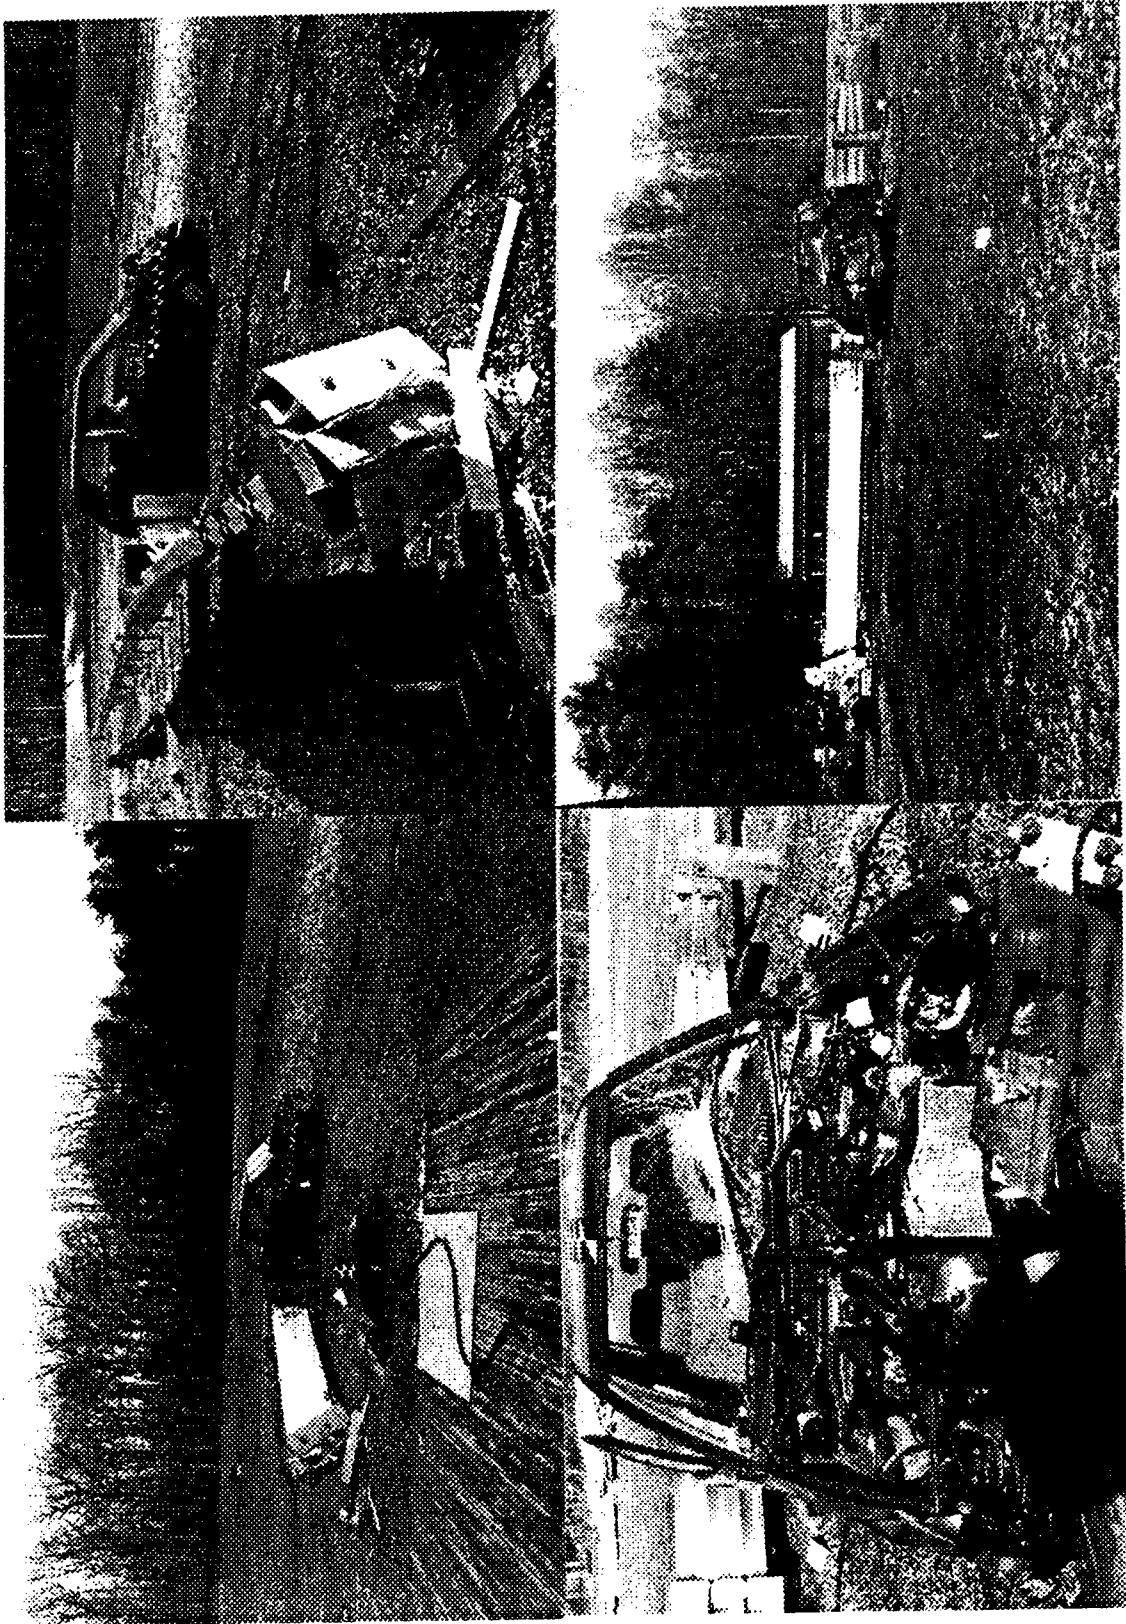
Figure 22. Post-test photographs, test 96F027.

Figure 22. Post-test photographs, test 96F027 (continued).

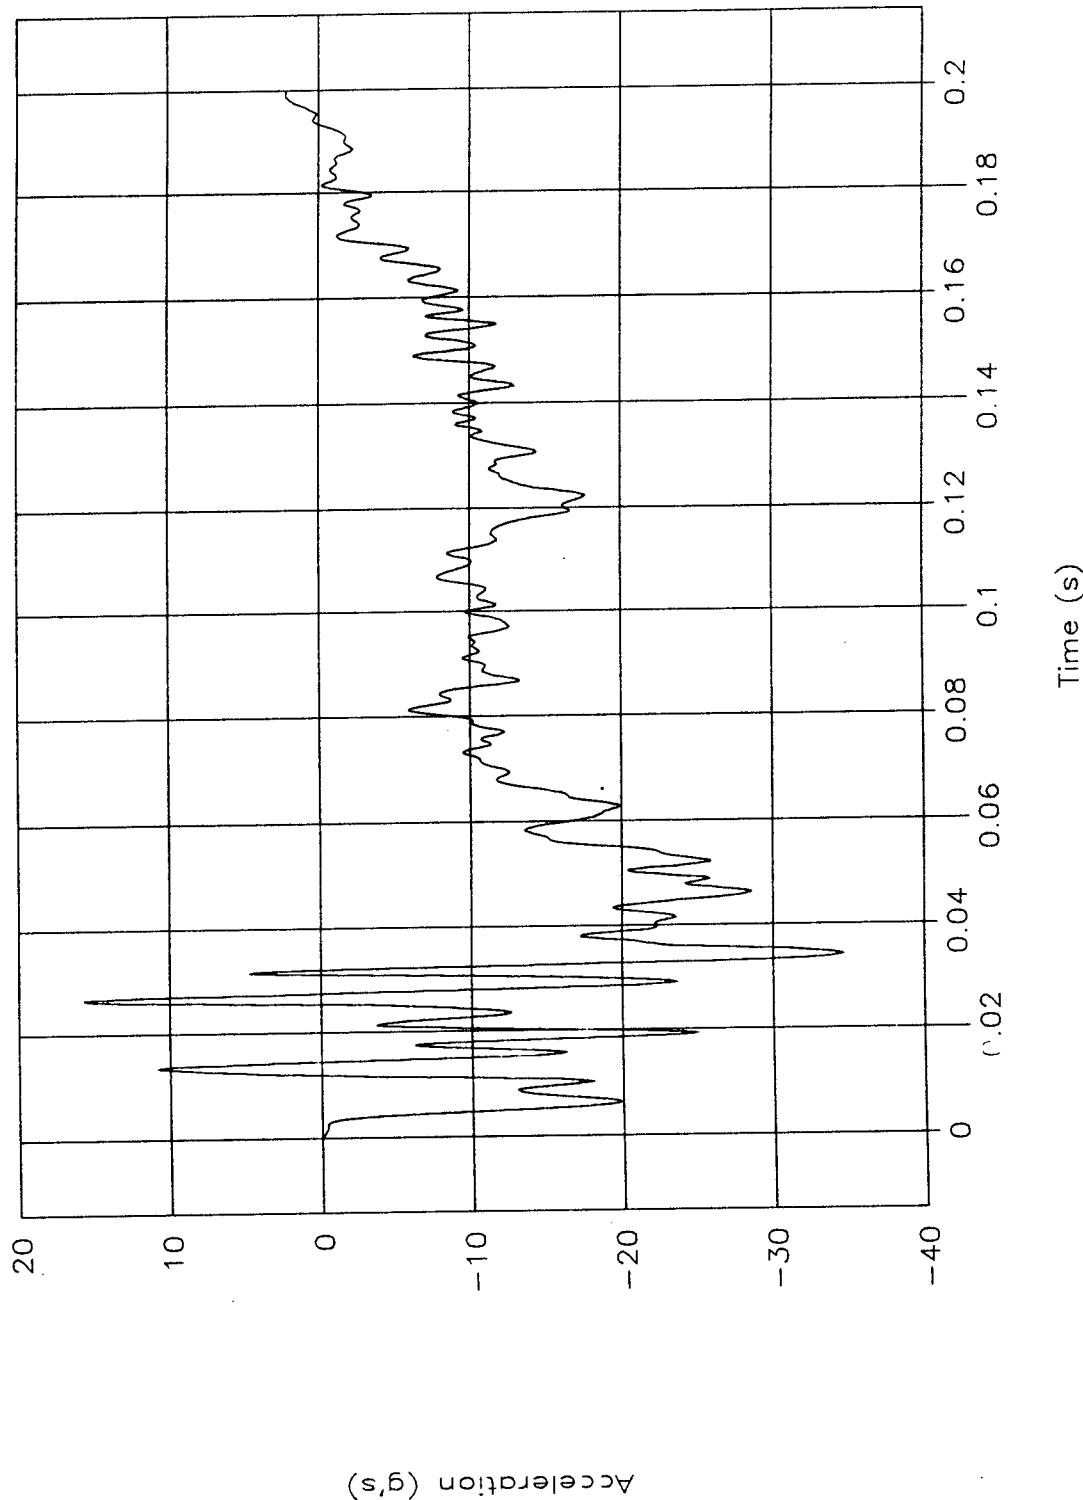
Figure 23. Acceleration vs. time, x-axis, test 96F007.

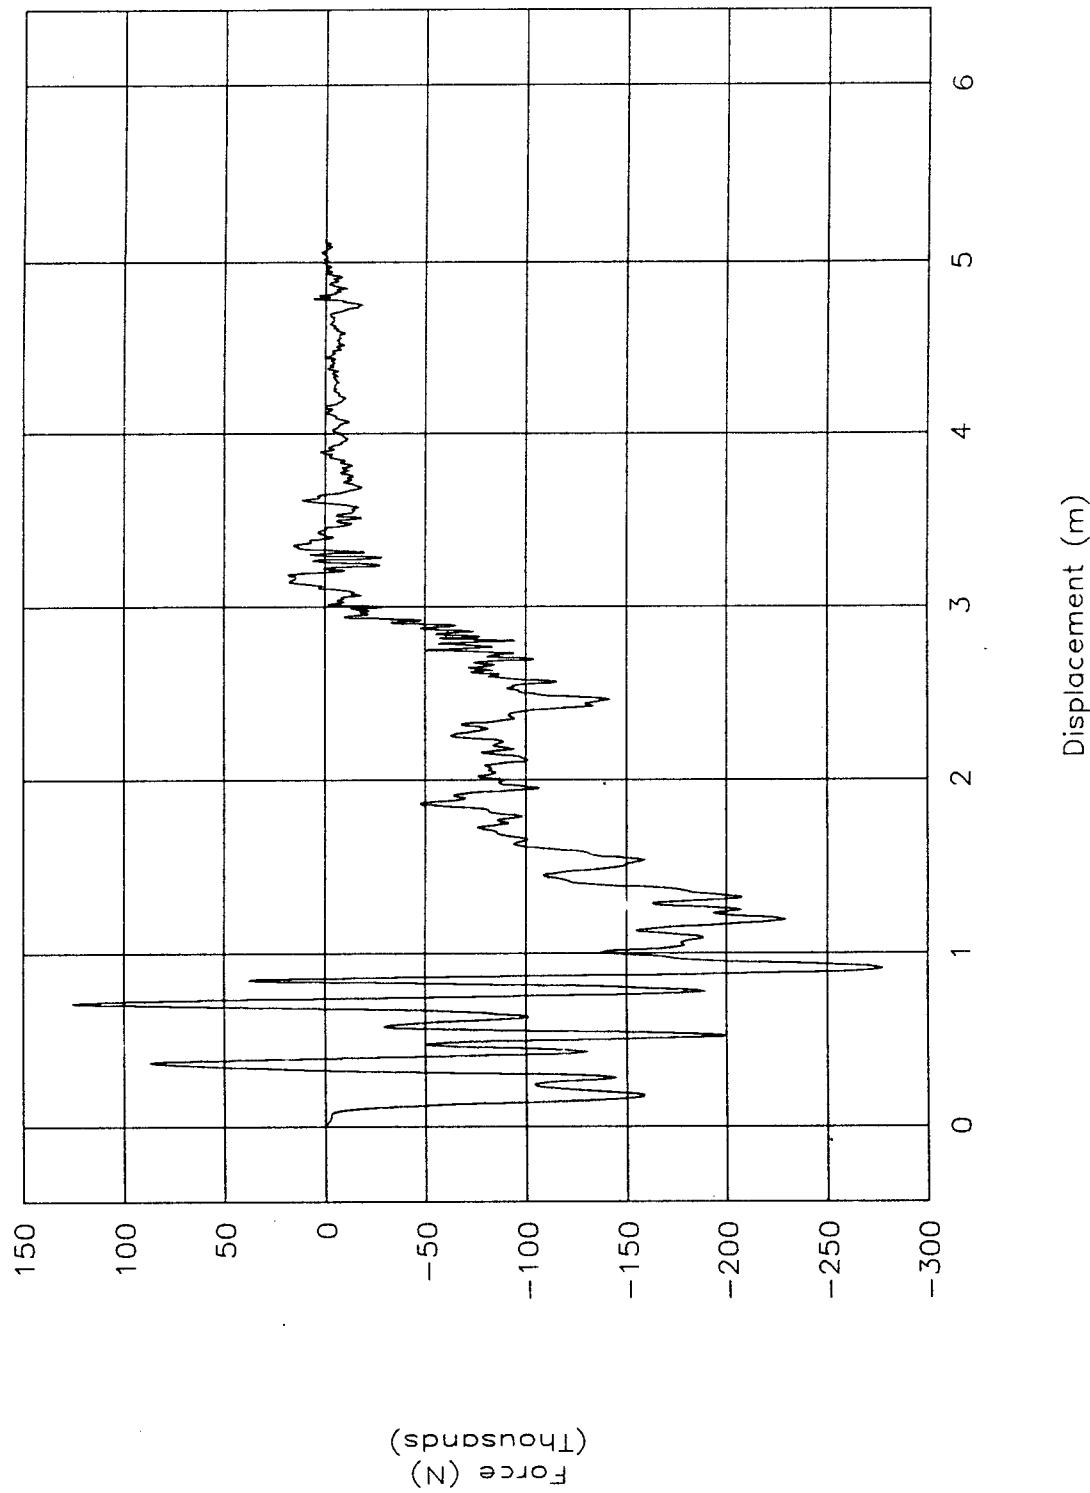
Figure 28. Force vs. displacement, test 96F007.

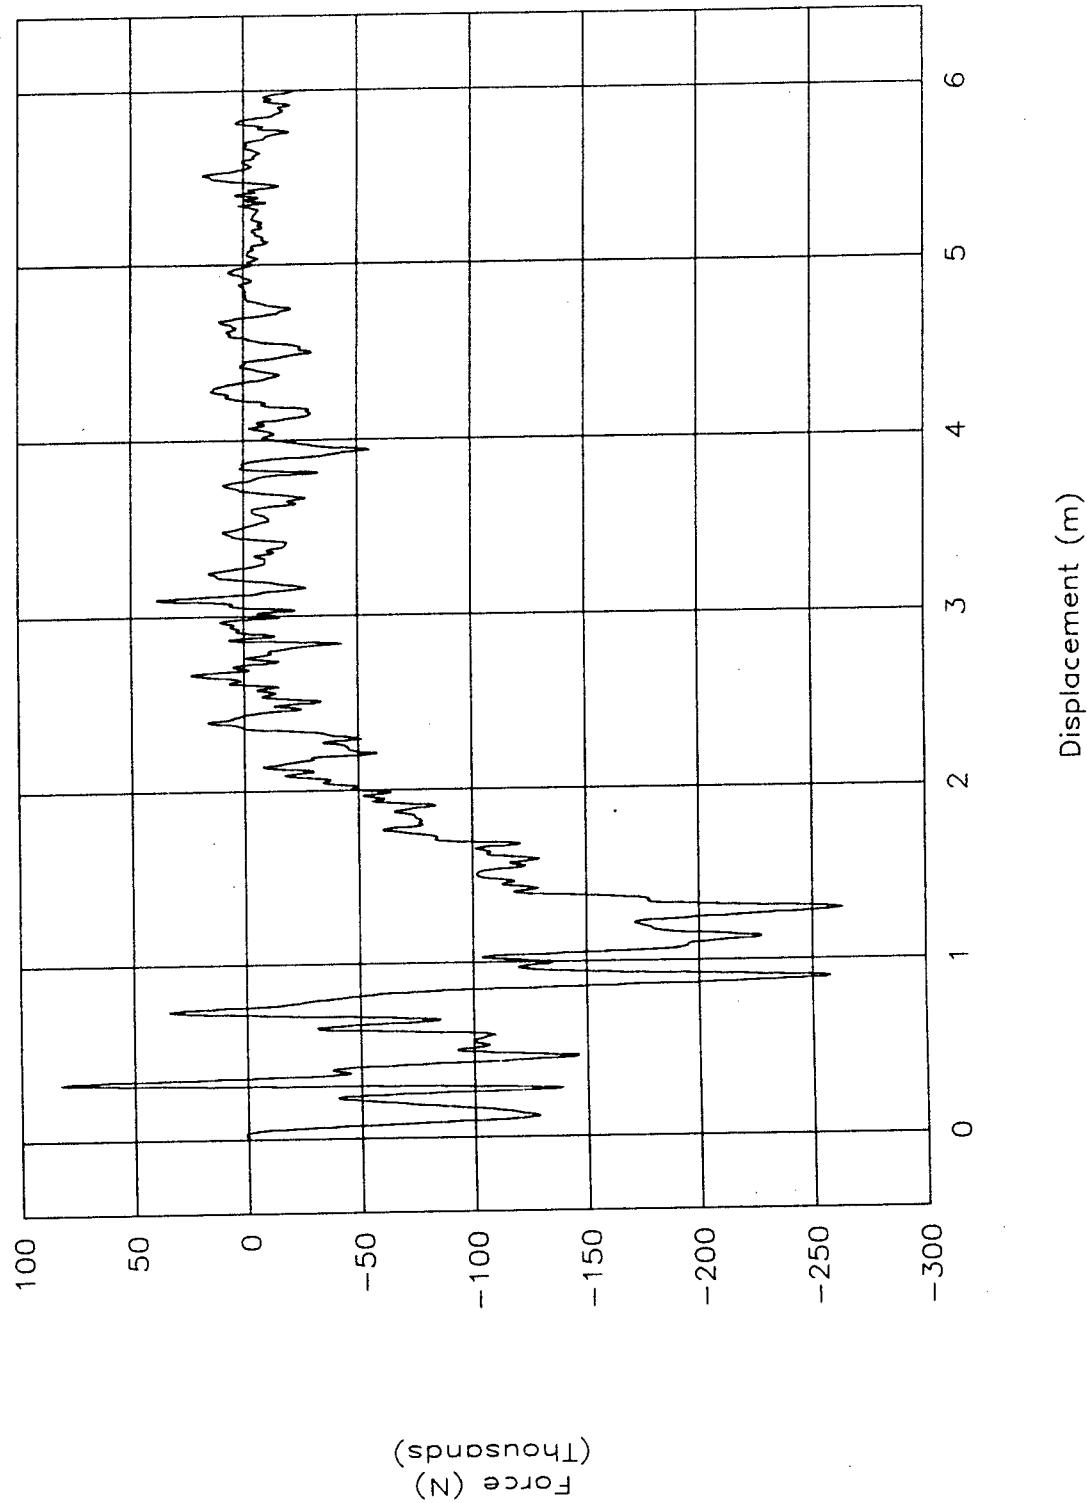
Figure 47. Force vs. displacement, test 96F016.
